An Analysis of the Causes of Damage to Nata de Coco in the Fermentation Process

3.6. Damage to Nata de Coco in the Fermentation Process

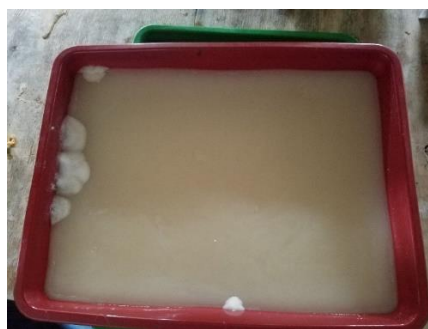
Figure 1 Damage to Nata de Coco as a Result of Fungal Contaminant

Figure 1 points out a damaged nata slab because of fungal contaminants, resulted by an unhygienic tray, facility, and infrastructure in the making of the media, leaving contaminants, such as dirt, sand, metal, and others. Tools used should be ensured for their hygiene to avert the transfer of contaminants, e.g., dirt, metal, sand, and so forth, which might cause damage or annoy the production process through contaminated tools (PPM dan PL, 2004).

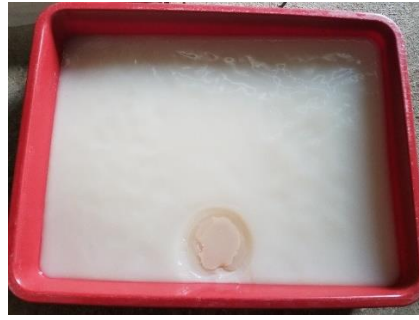
Figure 2 Damage to Nata de Coco in Light of Damaged Paper

Figure 2 presents a damaged nata slab by virtue of paper damage due to workers pouring the media carelessly and covering the tray with paper in such a way that the paper was perforated and torn. This hindered sunray exposure and fungal contaminants, e.g., dirt, sand, metal, and so on to compromise the fermentation process of nata.

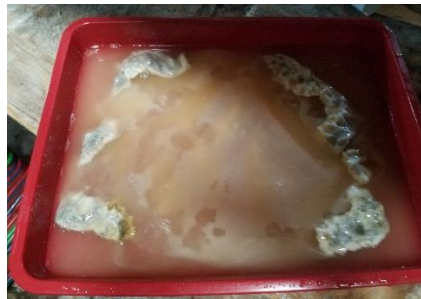
Figure 3 Nata Damage in Light of Starter Quality

Figure 3 shows a damaged nata on account of the quality of a starter for *Acetobacter xylinum* and sun ray exposure. The starter was not ready yet by age. This was commonly on grounds of the placement of the tray media, which was put on the top shelf near the outdoor wall, causing sun rays to expose and confound the fermentation process. The making process of nata de coco was determined by several factors. The growth of *Acetobacter xylinum* as the requisite bacteria in the fermentation process of coconut water was determined by oxygen, pH, temperature, and nutrition. These factors should be concerned in order to acquire quality nata de coco. Additionally, rigorousness and tool hygiene were also salient in the making of nata de coco. The latter greatly relied on tool sanitation and the correct use of materials.

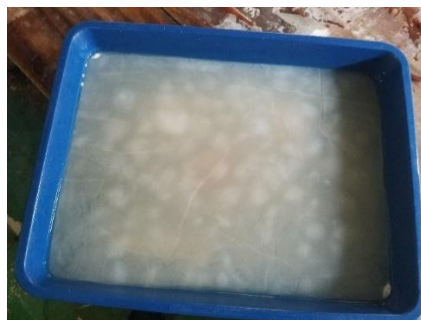
Figure 4 Nata Damage Owing to Incubation

Figure 4 showcases damage to a nata slab as a result of improper media incubation or storage, yielding a poor formation process of nata because of unprepared media for nata harvesting. Fermentation duration determined the formation process of nata (Wahono, 2016). The longer the fermentation period, the more hardened or chewier the nata texture. Within a proper range of periods, *Acetobacter xylinum* could convert glucose into cellulose fibers which were called nata. Moreover, a short fermentation period would likely create a rough nata texture by virtue of poor nata formation by *Acetobacter xylinum*.

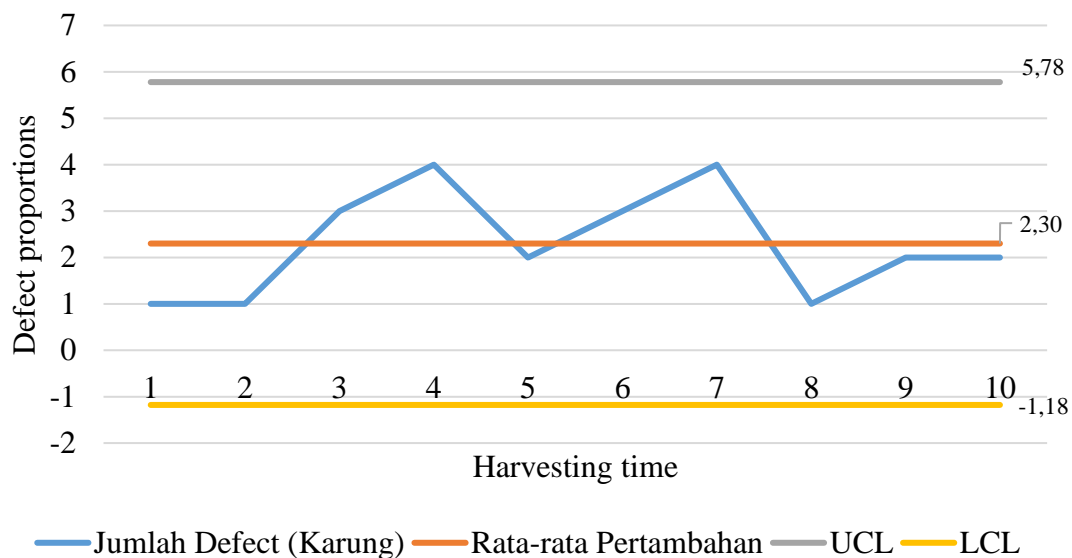
Figure 5. Control Chart of Defective Nata de Coco Products in the Fermentation Process

Figure 5 shows off the control chart of damaged nata de coco in the fermentation process. The highest number of sacks of defective nata de coco was four, elicited after a ten-time harvesting process of nata slabs (one sack = 25 kg). Figure 5 demonstrates that damage coming to the fore in the fermentation process was still normal or controllable, and accordingly, did not go beyond the top threshold, i.e., 5.78. As such, to hinder more damage, some improvements should be made in the fermentation process of nata de coco, as regards either the handling of raw materials, hygiene of tools, facilities, and infrastructures, quality of a starter of *Acetobacter xylinum*, and quality of human resources.
