Cause Analysis of Cutting Process Problems on The Size of Nata De Coco Cutting Type NDC 12

Aria Azizah Ahmad Ghani, Safinta Nurindra Rahmadhia

Food Technology Study Program, Faculty of Industrial Technology, Universitas Ahmad Dahlan, Indonesia

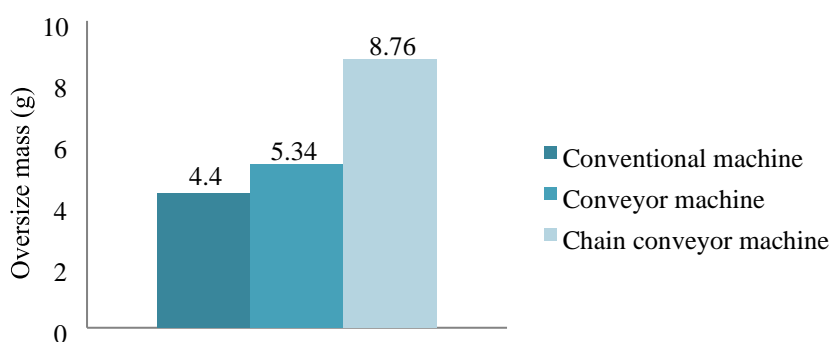
Figure 2. Nata de coco pre-sort oversize average value comparison chart

cutting machines, conveyor machines and chain conveyor machines is shown in Figure 2 and Figure 3. Based on these figures, the results show that both pre-sorting and post-sorting treatments, the highest oversize value is found in the results of pieces using a conveyor machine. chain, with a pre-sorted oversize value of 8.76 g and a post-sorting oversize value of 5.23 g.

Nata with defects that are sorted will then be sold to other consumer segments, of course at a cheaper price compared to the price of nata in general, so that this can reduce company revenue and increase raw material costs considering the number of nata sheets that are cut have many defects. So, it is necessary to take action to handle maintenance and repair of nata de coco cutting machines, especially on chain conveyor machines to minimize the number of defects produced.

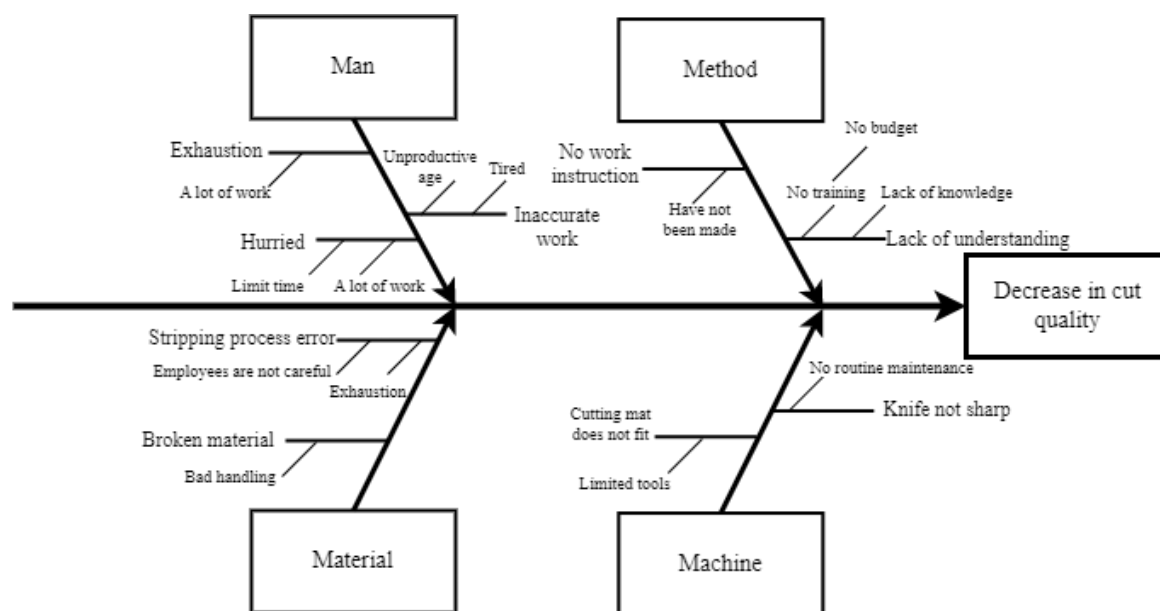
Figure 4. Fishbone diagram of decrease in cut quality

Fatigue makes the performance of workers decrease, thus hampering the smooth cutting process of nata de coco. Generally, fatigue is caused by age, health conditions, sleep quality, and the intensity of working time. High total production achievement due to increased consumer demand forces workers to complete the nata de coco cutting process in a short time, this actually makes workers rush, thereby reducing the level of accuracy. Lack of accuracy in the use of production equipment is also a factor causing the decline in the quality of the final product. The addition of workers in the nata de coco cutting process division can be a solution to avoid obstacles to the work process due to increased production intensity.

The work instructions in the nata de coco cutting process that have been made and determined are not well understood and applied, so that the implementation of the work process tends to be inconsistent with what should be done. The work instructions that have been made should be better understood and applied in the implementation of the work process, in-depth supervision and control are needed for each division, especially in the nata de coco cutting process to maintain the smooth production process for the quality of the final product.

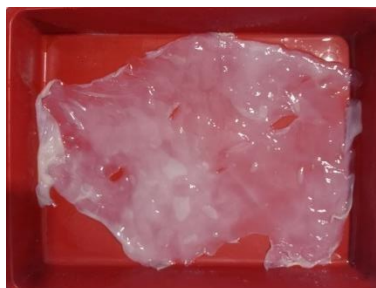
Figure 5. Nata de coco's flesh with physical damage

In the process of stripping the epidermis, there is usually physical damage to the harvested nata that is being peeled. Lack of accuracy in peeling the epidermis results in the condition of the nata de coco's flesh being peeled or torn in the middle and ends. So that the peeled nata has an uneven surface and creates a fairly deep incision (Figure 5). Nata with an uneven surface when flattened by splitting into nata sheets will result in poor sheet quality. The nata sheet in question has the characteristics of imperfect sheet shape, different sheet thickness, there are incision marks on the surface and so on (Figure 6). So, it is necessary to control and supervise pre-cutting to avoid physical damage to the sheet nata, especially in the process of stripping the epidermis.
